## BOOTT COTTON MILLS (The Boott Mills) Lowell, Massachusetts

# Tech Notes

NUMBER 18

### Aluminum Replacement Windows With True Divided Lights, Interior Piggyback Storm Panels, and Exposed Historic Wooden Frames

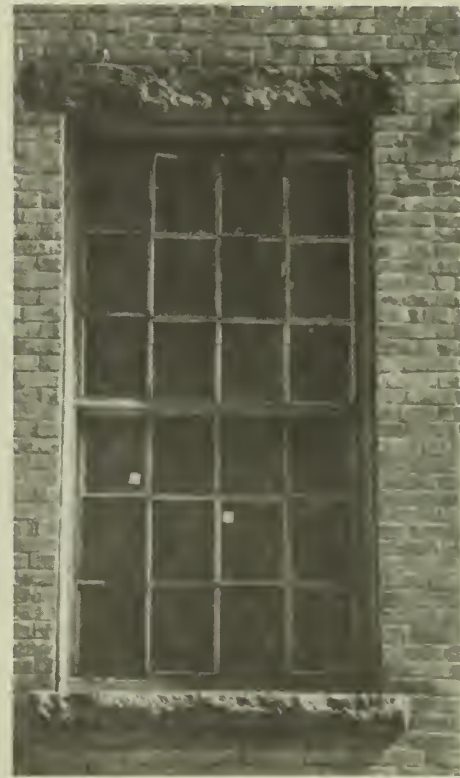
The projected three-phase, \$63 million rehabilitation of the Boott Mills involves 700,000 square feet of space. An appropriate window treatment was foremost among several important preservation design problems. The developer and the historic review commission agreed that one-over-one aluminum replacement windows with exterior muntin grids were not desirable. Because of the significance of the complex, it was established that the windows needed to have true divided lights and that the dimensions and profiles of all visible elements would be near copies of the originals (see figure 2).

Figure 2. Because of the historic character and significance of the complex, replacement sash needed to have true divided lights and the dimensions and profiles of visible elements needed to be close copies of the originals. Photo: Courtesy of Huygens DiMella Shaffer

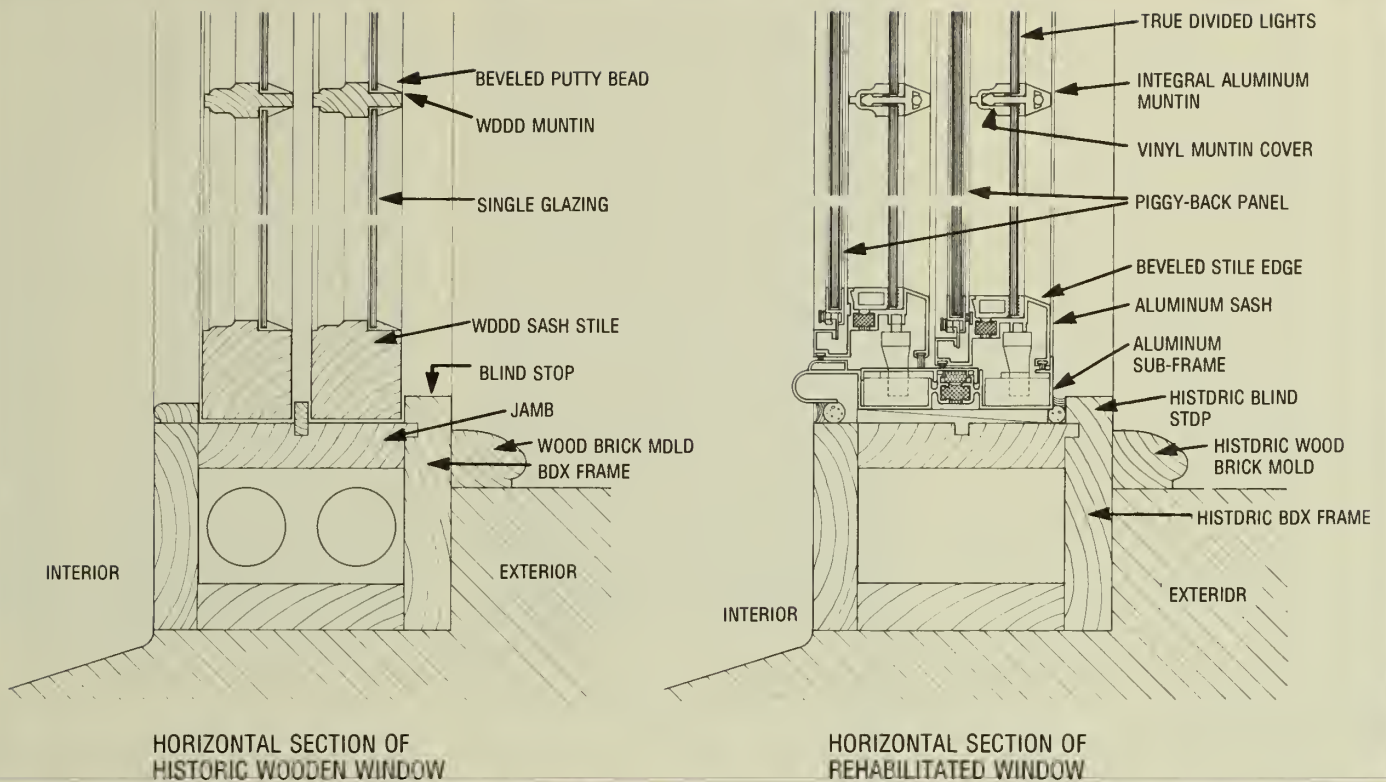
Figure 3. Horizontal section of the window shown with old and new sash. Drawing: Timothy Buehner

Boott Mills, it was necessary to limit the muntin-supported glass panes to single glazing, as in a historic window, and to achieve double glazing with a secondary window system (see figure 3). This secondary window consisted of a "piggy-back" interior glazing panel, which left exposed on the exterior the multiple facets of the true divided lights so characteristic of historic multiple-pane windows. The interior glazing panel was attached to the room side of the sash. It was also decided that the existing wooden frames would be retained and used to receive the aluminum sub-frame for the new window. Finally, new aluminum extrusions were to be made for all members to ensure a very close match to the historic units.

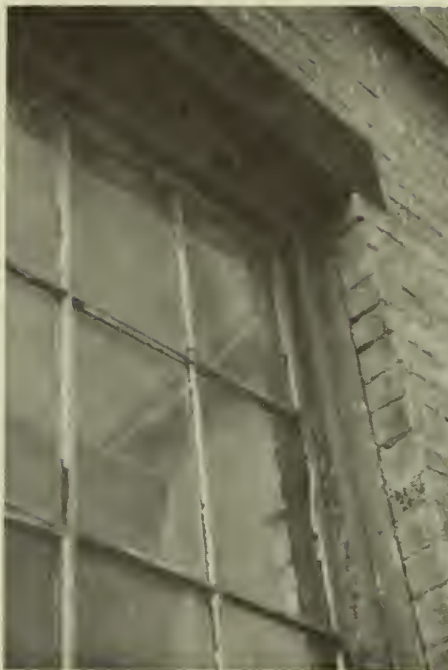
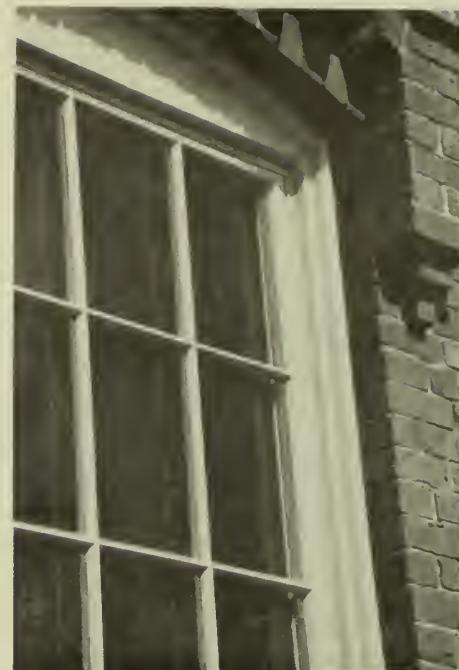
**Figure 4.** The decision to use an integral muntin for the outer glazing and a piggy-back interior glazing panel was an important component of the successful window solution. Sash shown before and after rehabilitation. Photos: Charles Parrott

was narrowed and profiled to approximate the beveled glazing bead and sticking of the historic wooden muntins. However, it was found that the technology of the 1985 three-piece muntin system could be reduced only to about  $\frac{7}{8}$ " in thickness. A new two-piece true muntin was then developed by the manufacturer that met the general dimensions and profile of the putty-glazed historic muntin; it provided the needed strength and proved to be simpler in design and less expensive to fabricate. This muntin consisted of an aluminum tee extrusion with a trapezoidal flange and a web terminating in a triangle-shaped point over which a profiled cover of extruded rigid PVC was snapped to hold the glass panes in place. Plastic was used for this cover to provide the flexibility needed to remove the cover in case of glass breakage and to provide the thermal break to insulate the aluminum tee member. The snap cover extrusion was to be made in the pre-selected custom color chosen for the window (see figure 4).

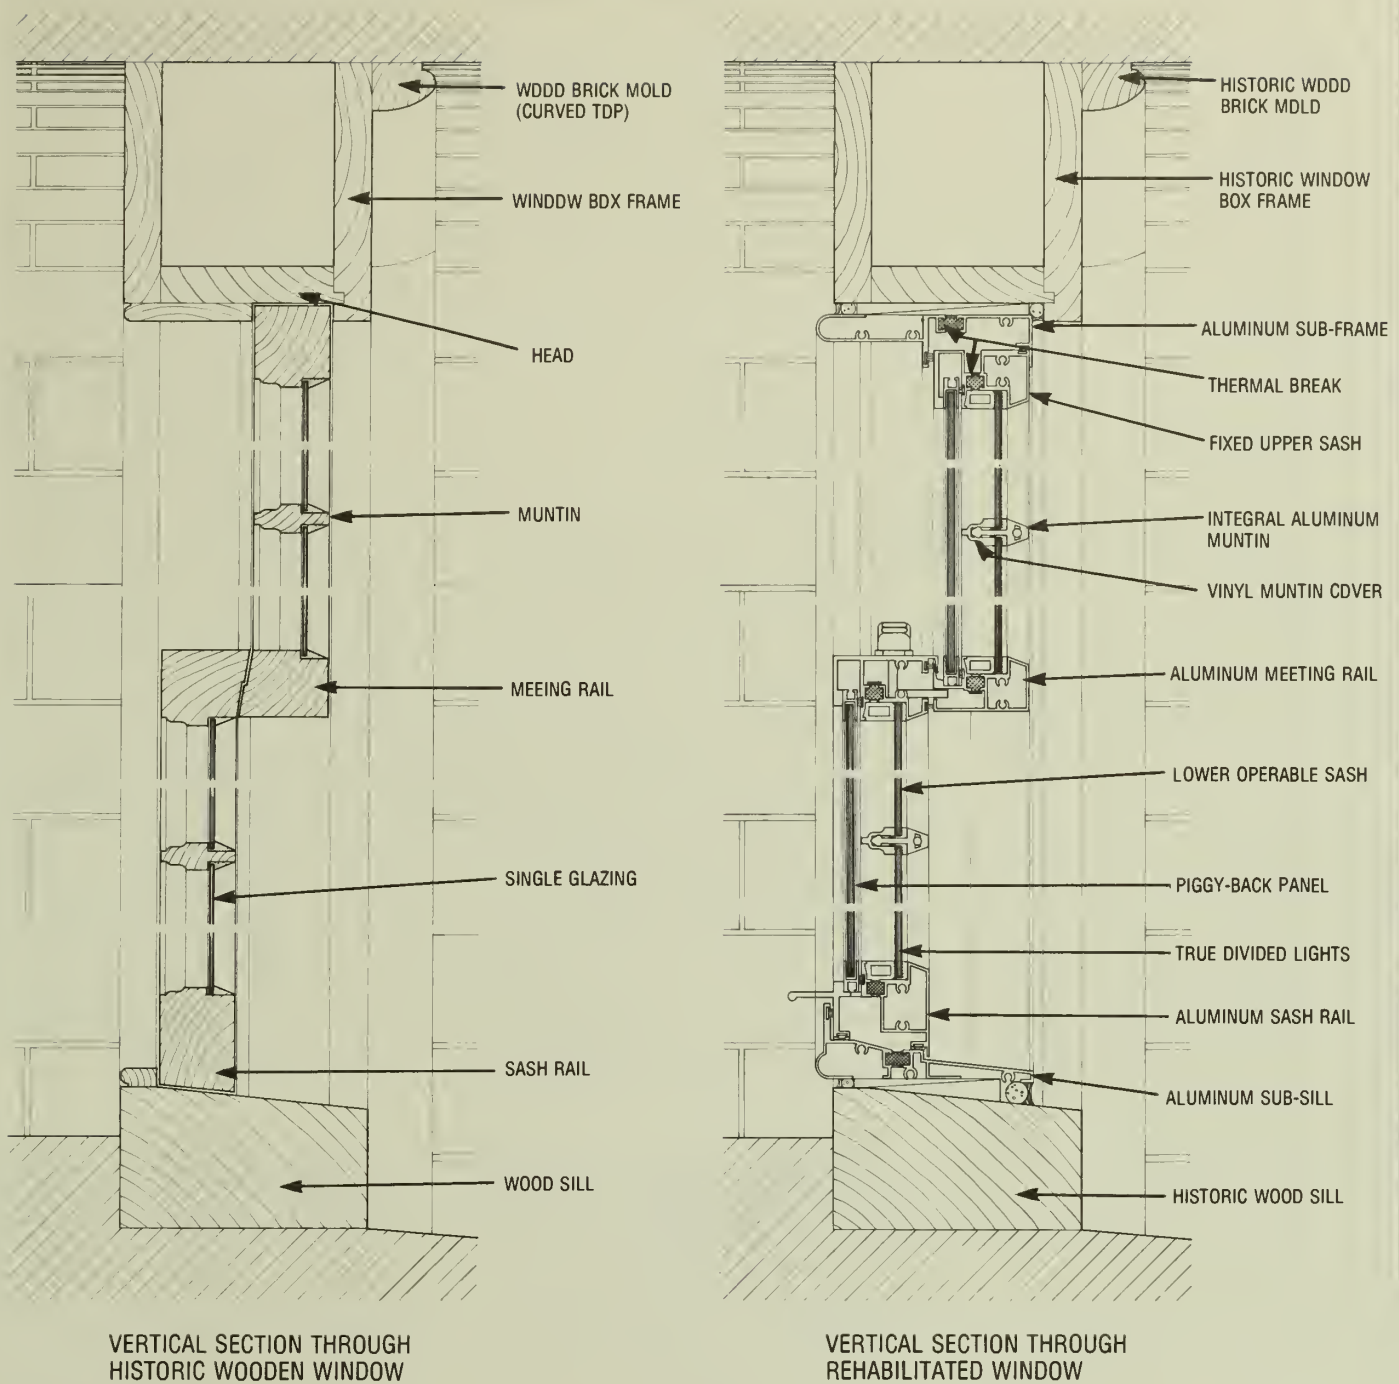
Figure 5. Vertical section of the window shown with old and new sash. Drawing: Timothy Buehner

On the sub-frame, a drip edge that broke the sight line at the head was eliminated as unnecessary. The detailing of the sub-frame was also revised to facilitate installation into the existing frame from the building interior. This resulted in a cleaner interior finish; however, it also increased the height of the sub-sill, making it somewhat more visible on the exterior. The overall depth of the early design was also reduced, resulting in a final depth only about  $\frac{1}{2}$ " larger than the historic window. Because the muntin had to clear the piggy-back panel behind it, the overall muntin depth was to be  $1\frac{1}{16}$ ", just  $\frac{3}{16}$ " less than the historic ones (see figure 5).

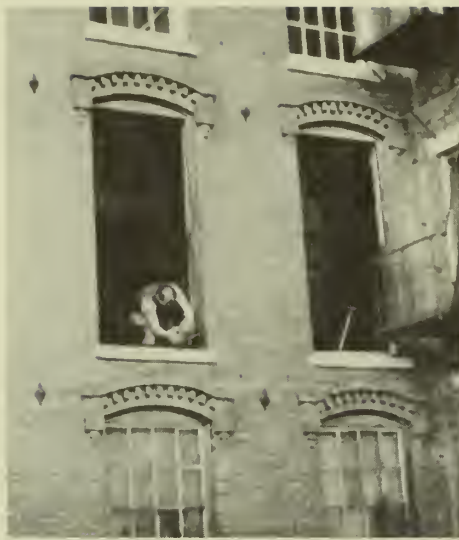
**Figure 6.** Work on the frames consisted largely of making dutchman repairs to the pulley stiles where required; re-nailing or replacing brick moldings; replacing some sills; and surface preparation. Photo: Charles Fisher

The exterior of the wooden frames were not to be panned or covered in aluminum. Thus it was important both for aesthetic consideration and good paint performance that the wood frames be repaired and surfaces properly finished. Work on the frames consisted largely of making dutchman repairs to the pulley stiles where required; re-nailing or replacing brick molding; replacing some sills; and scraping, filling and sanding wood surfaces. Painting consisted of priming and two coats of alkyd oil paint (see figure 6).

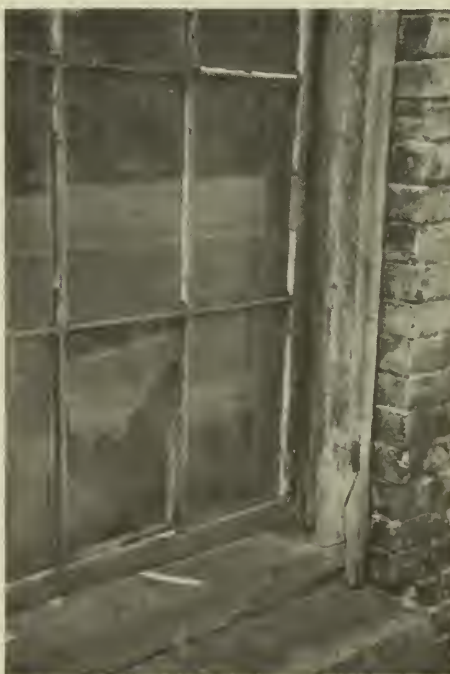
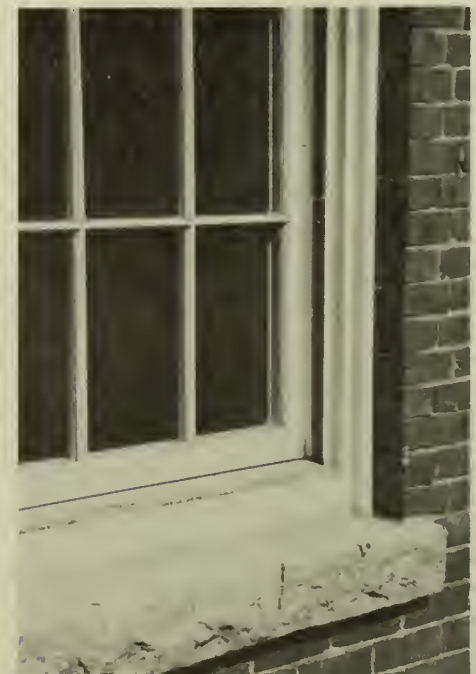
**Figure 7.** The retention of the exposed outer face of the historic wooden frame and the sill detailing were important qualities of the window treatment. Before and after photos: Charles Parrott

Installation of the new sash went quickly and smoothly. First, the sub-frame was inserted in the prepared opening from the room side, shimmed to plumb, line and level before attaching screws through the head and jambs into the old frame. The sash were then installed and the windows were caulked on both the interior and exterior to complete the work (see figure 7).

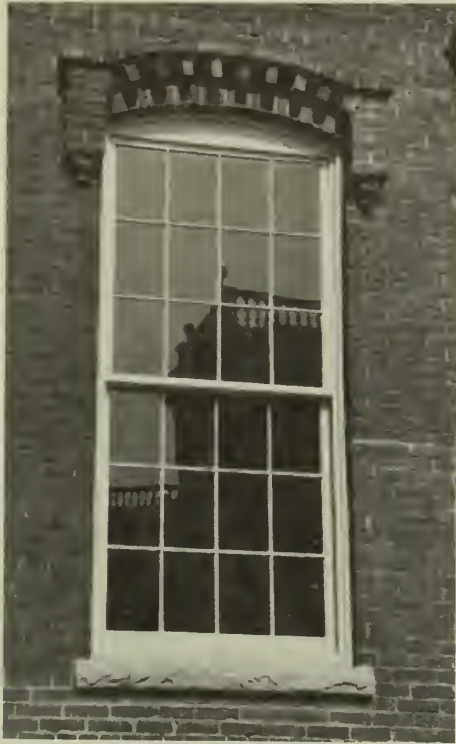
Figure 8. Replacement window sash after installation. Photo: Charles Parrott

As with any successful window solution, there are opportunities for refinement. Modification of the glazing vinyl gasket and associated extrusions was subsequently acknowledged as an area for potential improvement, to approximate more fully the historic muntin profile around the sash frame. The sill of the aluminum sub-frame could also have been detailed better, following more the slope of the original wood sill.

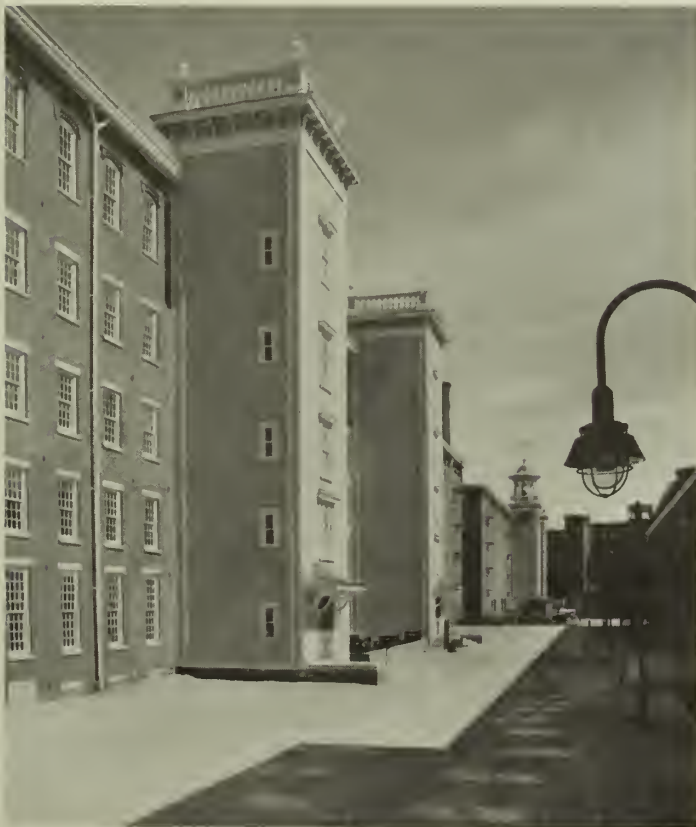
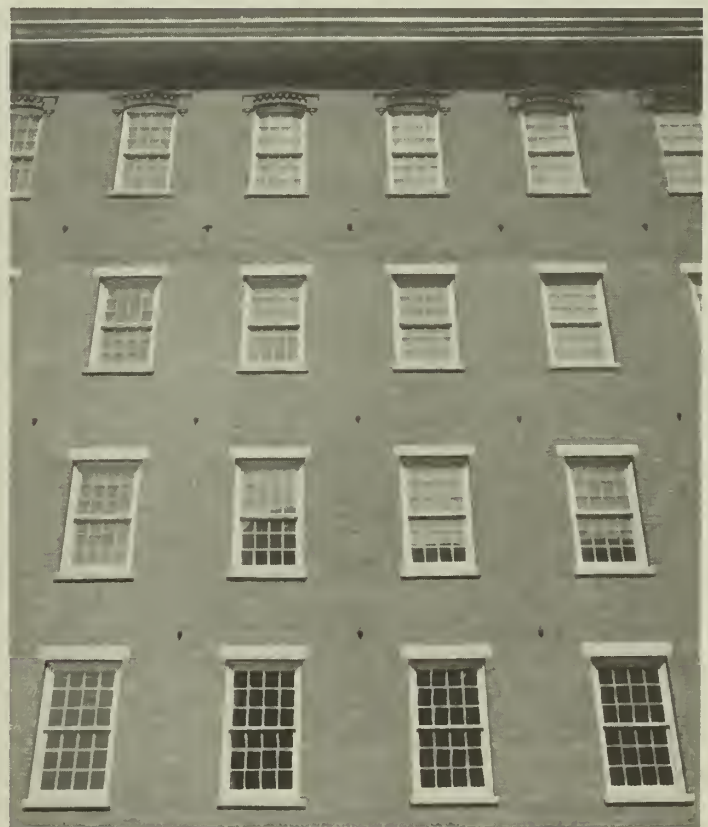
Figure 9. The window solution represents an important advance in the way in which aluminum windows can be designed to capture more fully the appearance of historic windows in larger buildings. Right photo shows wood sash in bottom row and aluminum in the upper three rows. Photos: Jim Higgins ©
